**PROCEEDINGS OF THE BROWN COUNTY
LAND CONSERVATION SUBCOMMITTEE**

Site Assessment Report (Country Aire Dairy)

Summary Country Aire Inspection

Country Aire Dairy
Inspection Report

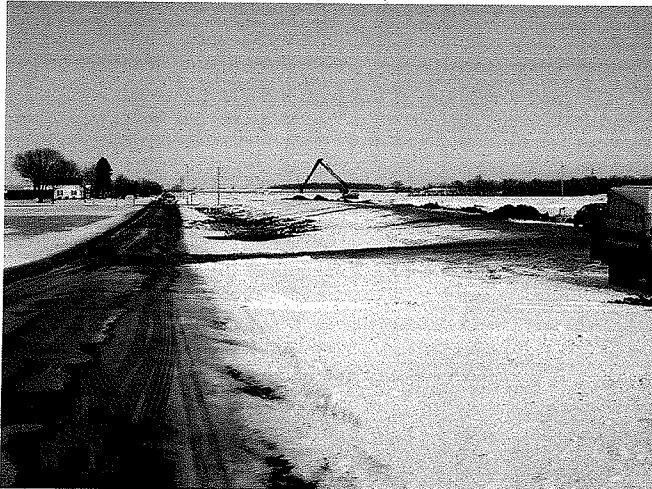
- The investigation began by observing the East River at several locations and taking pictures.
- Arrived at Gerrits and observed the area on the west end of pit where the berm was dug up the day before (Tuesday). The stormwater pipe was cut and plugged in two locations on the west end of the pit. See pictures below.
- Talked with Mike Gerrits and he was confident the stormwater pipe was plugged properly in both locations on Tuesday. On-site clay was used. Mike stated he was concerned with stormwater pipe and that he was never comfortable having the pipe through the berm. It seemed to be the easiest and a shorter distance to put the stormwater drainage there.

(Stormwater Outlet Looking North)

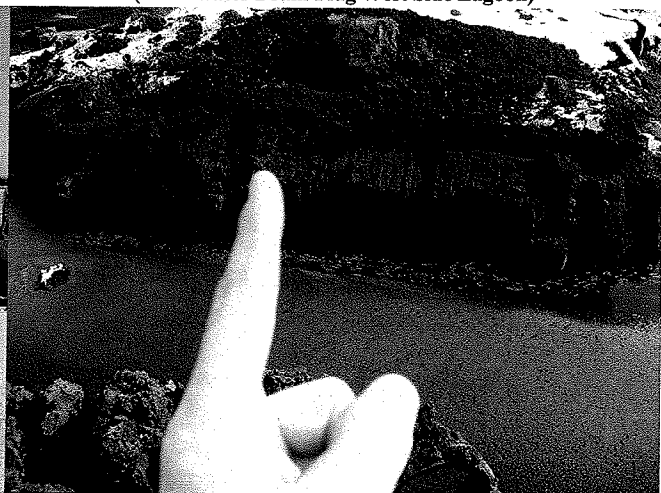
(Stormwater Drain Plug West Side Lagoon)

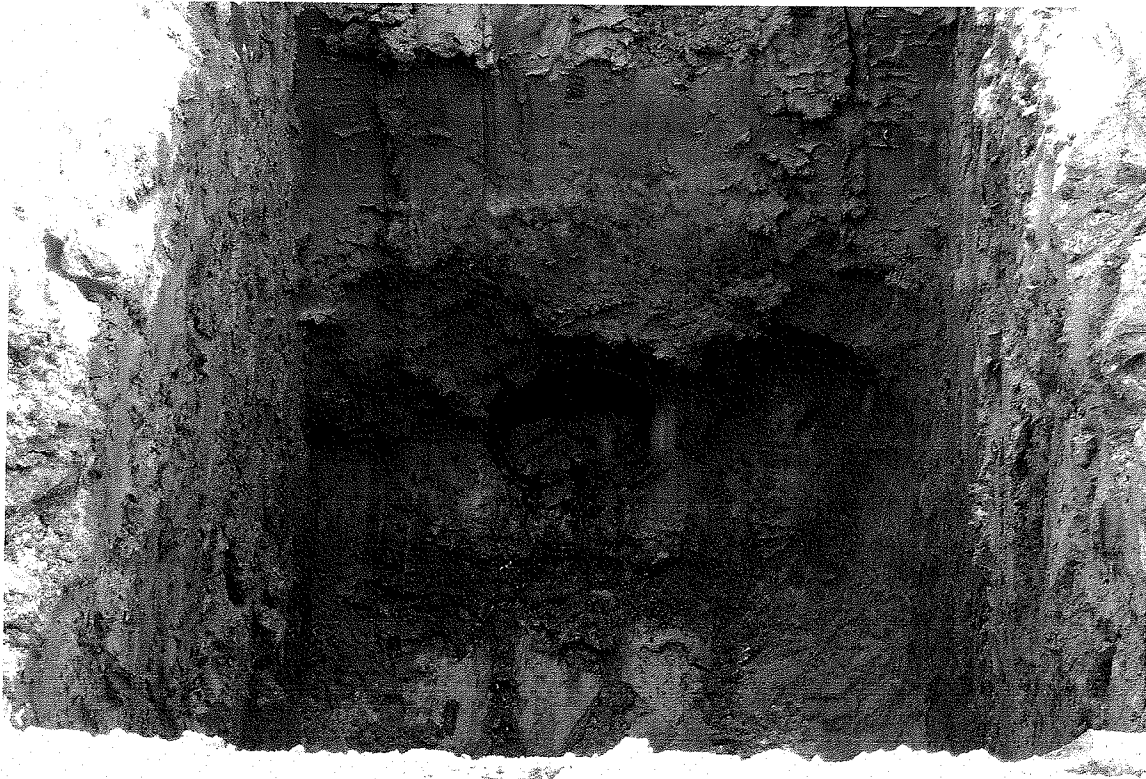
- Met Excavator (Dave) at 3:00 pm. and found the manhole grate. Used the backhoe to find the 15" P.E. culvert pipe in the middle of the separation dike, on the east end of the pit. Removed 10-12 ft. of the pipe and recompact the clay in the trench to block up pipe. During removal of the pipe, manure was back flowing from the open end of pipe or the west side of the pit. It was plugged with clay and the trench was backfilled and compacted. The excavator stated he did the same thing on the west side of the pit to block the pipe. When the excavator came on site to plug the initial leaking pipe (on Tuesday 3/4/08) a trench was already cut between the two manure storages to allow an overflow from the south pit to the sand cell pit because the manhole drainage system was not working. The excavator did not say who did the digging but suspected it was the pipe installer. The excavator said they had to dig about 2 ft. down in the trench to hit the stormwater pipe. He stated the pipe did not look as though it was sloughing or differential settlement had taken place with the stormwater pipe. The excavator did state that a scratch or gouge was seen on the pipe that may have accordioned the pipe and separated it some to where it allowed manure water from the south pit to seep into it. Much of the pipes were covered in manure / snow and hard to see detail. To plug the pipe the excavator said he dug the overflow deeper and the storm water pipe crushed. A trench was dug, the pipe was removed and then backfilled. This was done on the west end as well. Manure from south cell flowed north and the elevation dropped several feet to allow repair to be made.

(Stormwater Drain Plug East Side Lagoon)

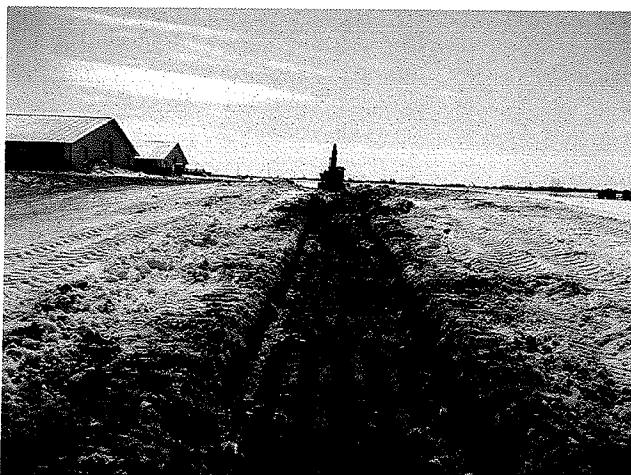
- The initial digging of the trench was dug to shallow and would impound 1.9 ft. of water in ditch and over manhole basin. The excavator did not want to dig deeper, in case of frost damage to pipe. Discussed this with the landowner and the ditch was dug at a flat grade of 0.6 tenths above the manhole grate instead. This will impound some water in the ditches at a depth of approximately 0.6 tenths. This will allow a deeper ditch and outlet for the stormwater basins between barns and still prevent pipe freezing. The new temporary stormwater ditch was completed and elevations were taken. This is a good temporary measure until the frost is out, then the ditch will be regraded to have slope out and culverts installed across road to the new north ditch from between the buildings. The stormwater system will be abandoned and figured into the new ditch system. The source pump pvc line and the electric lines may then be lowered by Braun Electric to maintain ground cover over the pipe if necessary.

(Temporary Stormwater Trench Looking South)

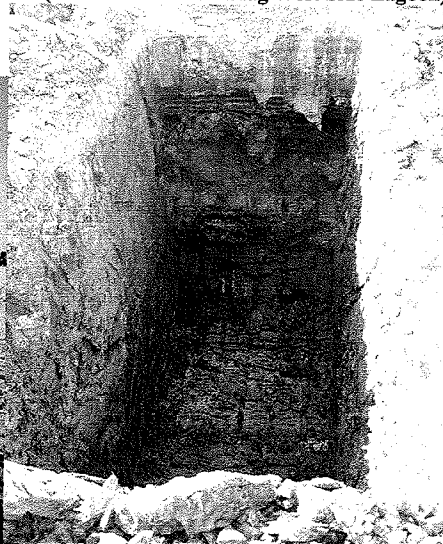
- After the stormwater ditch was completed the rest of the east stormwater plug was filled and compacted.
- Decided to remove more stormwater pipe on the west end of the pit to be safe and for proper documentation. Pipe was removed to approximately 10 ft. west of the existing manhole. Clean clay was used for backfill and compacted in 6-9 in. lifts. The inside side slope at this point was shaped to follow a 2:1 slope.

(Stormwater Drain Plug West Side Lagoon)

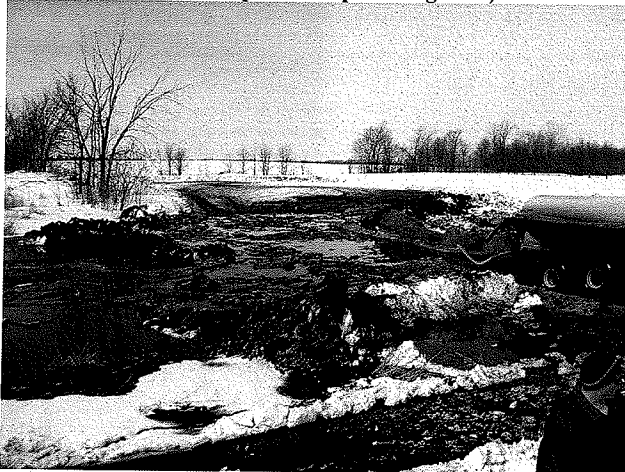
(Clancy Site Initial Pump Out Sump Looking West)

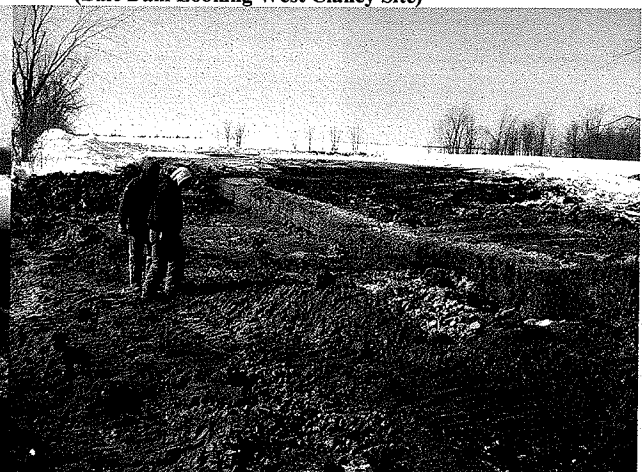
- Met with the same excavator from J & E construction as the previous days and discussed constructing a dam across the intermittent stream to the west of Old 57 Road on land owned by Bill Clancy. The weather is supposed to turn warmer in a few days and a large melt off and surface water drainage is expected. The purpose of the dam is to slow water down, allowing any manure solids to settle. When the water reaches approximately 3 ft. it will flow over the bales. Construction started around 11-11:30 a.m. The stream bottom was leveled somewhat and 11 large square bales were placed across the stream. The bale dimensions were approximately 3 ft. high and 8 ft. long, so close to 90 ft. of dam was constructed. Behind the entire length of bales 3-6 in. breaker rock was placed. The rock was placed to the height of the bales and then sloped downstream at a 3:1 slope (approximately 9 ft. to stream bottom). Used close to 34 yds of rock (2) 17 yd truck loads. Toward the end of constructing the dam, Jason Moeller of the DNR stopped and stated the job was adequate and would meet DNR's approval. Observe the construction pictures below.

(Bale Dam Looking West Clancy Site)

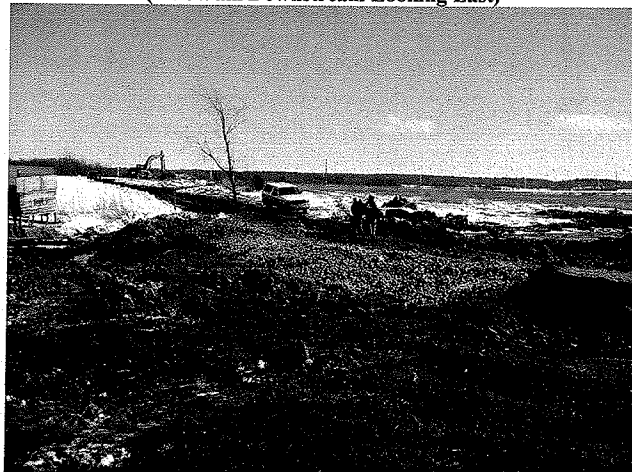
(Bale Dam Downstream Looking East)

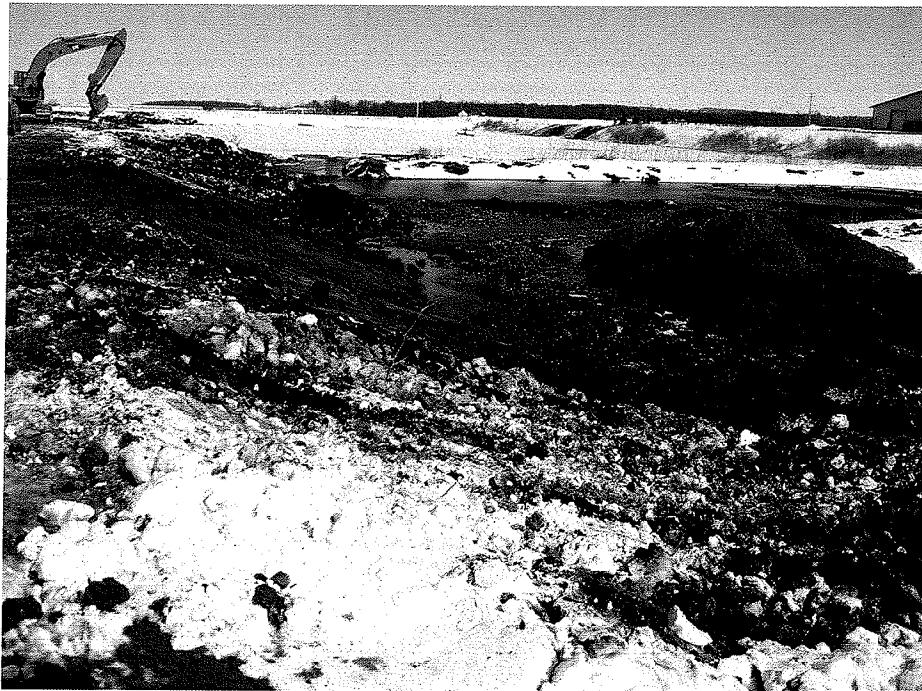
(Side Slope Repair Looking North)

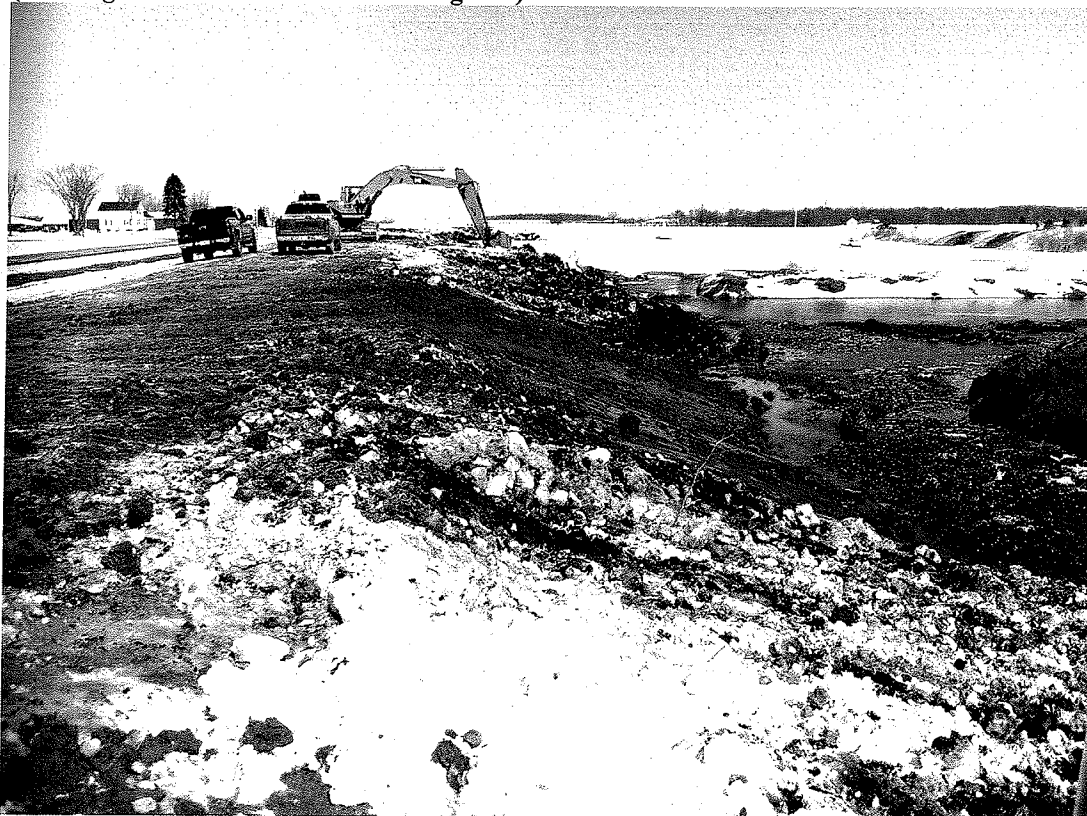
Country Aire Dairy, LLC is located at 7380 Old 57 Road in Greenleaf, Wisconsin. A large manure spill was reported by Mike Gerrits early Tuesday morning March 4, 2008. It is believed a stormwater pipe running in the berm between two lagoon cells separated or in some way failed and allowed flowing water to breakdown the south lagoon's liner. This allowed manure to flow into the stormwater pipe, which outlets to the ditch. Approximately 32,000 gal / hr is believed to have left the site and flowed towards a tributary of the East River. It is believed some of the spill made it as far north as Wisconsin Highway 96.

(Looking North down West berm of lagoons)

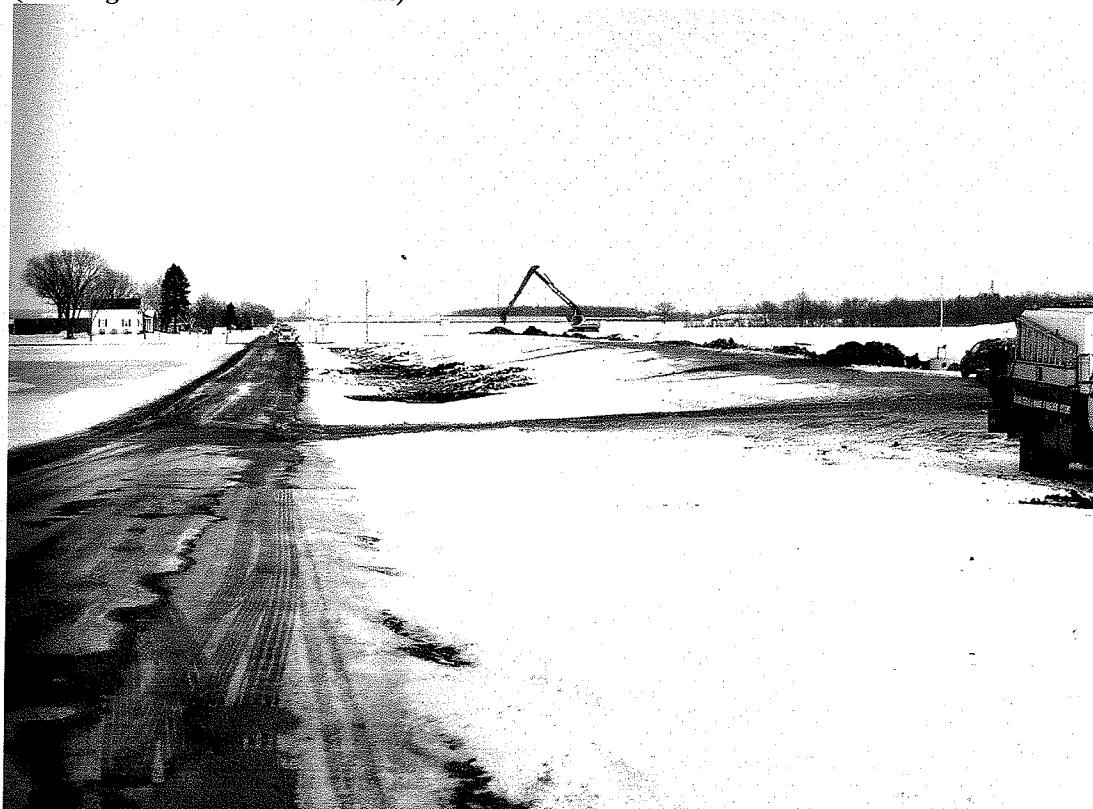
(Looking North down Old 57 Rd.)

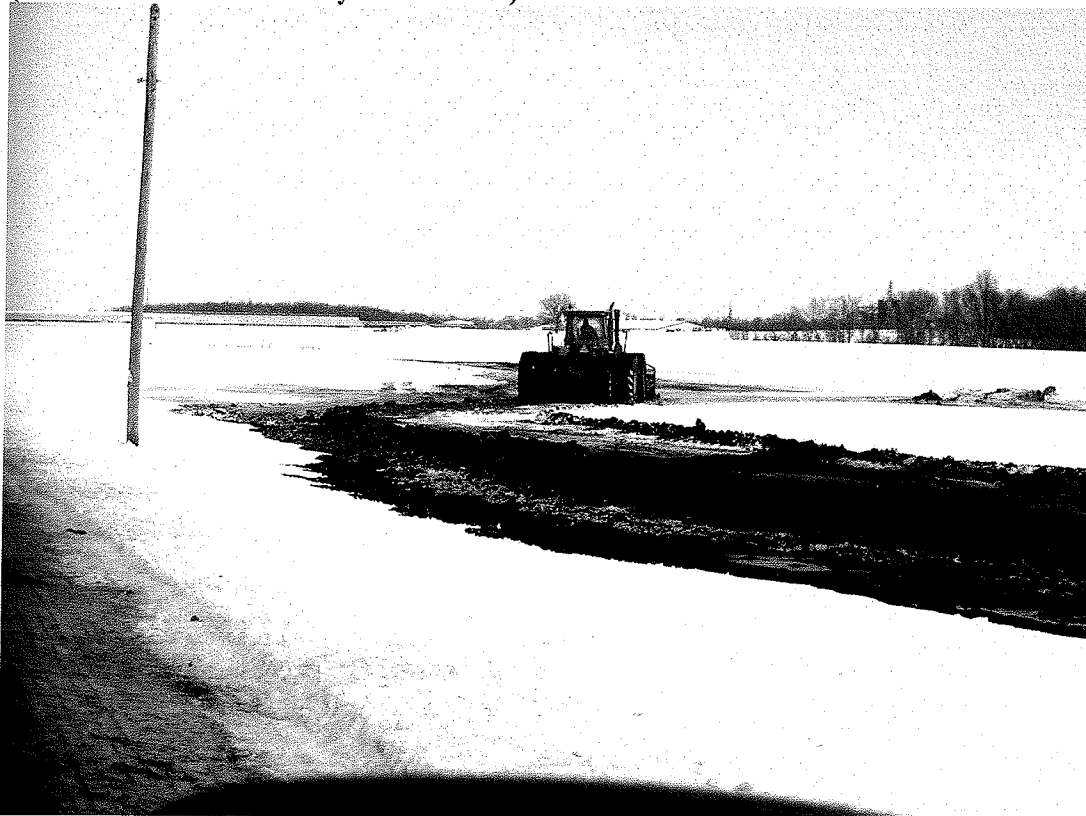
(East of Old 57 Rd. Tributary of East River)

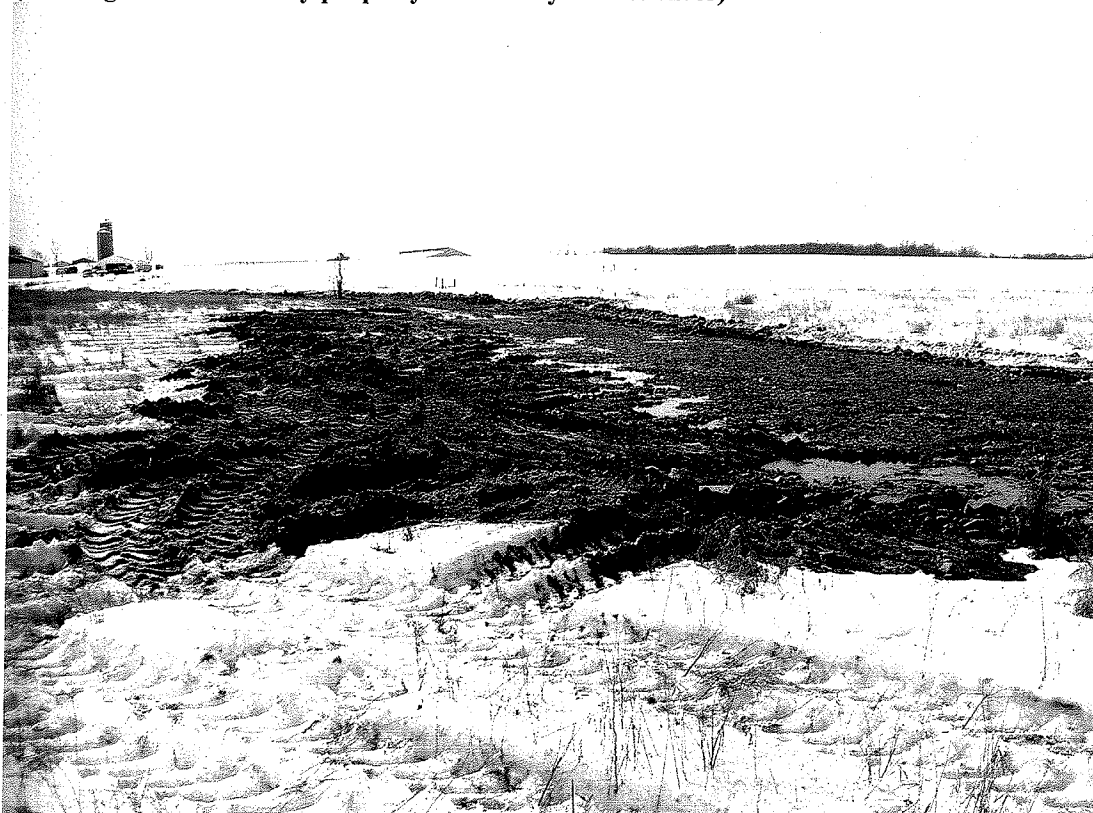
(Looking South on Clancy property - Tributary to East River)

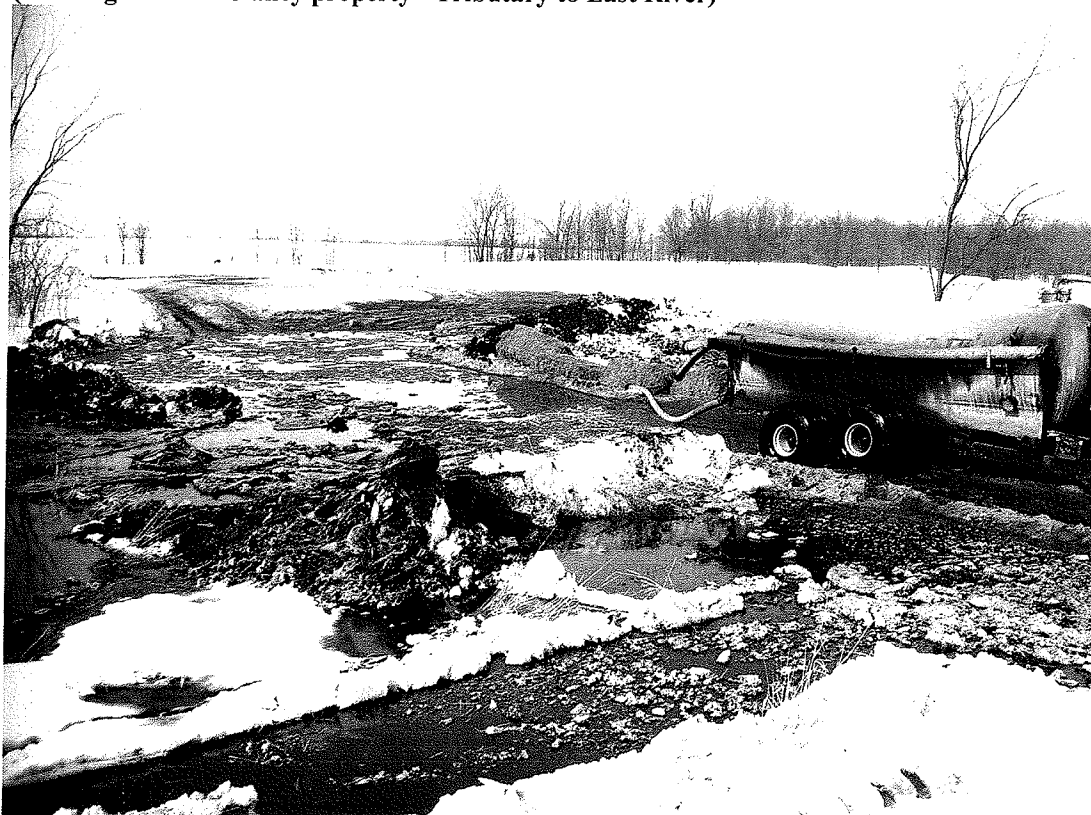
(Looking West on Clancy property - Tributary to East River)

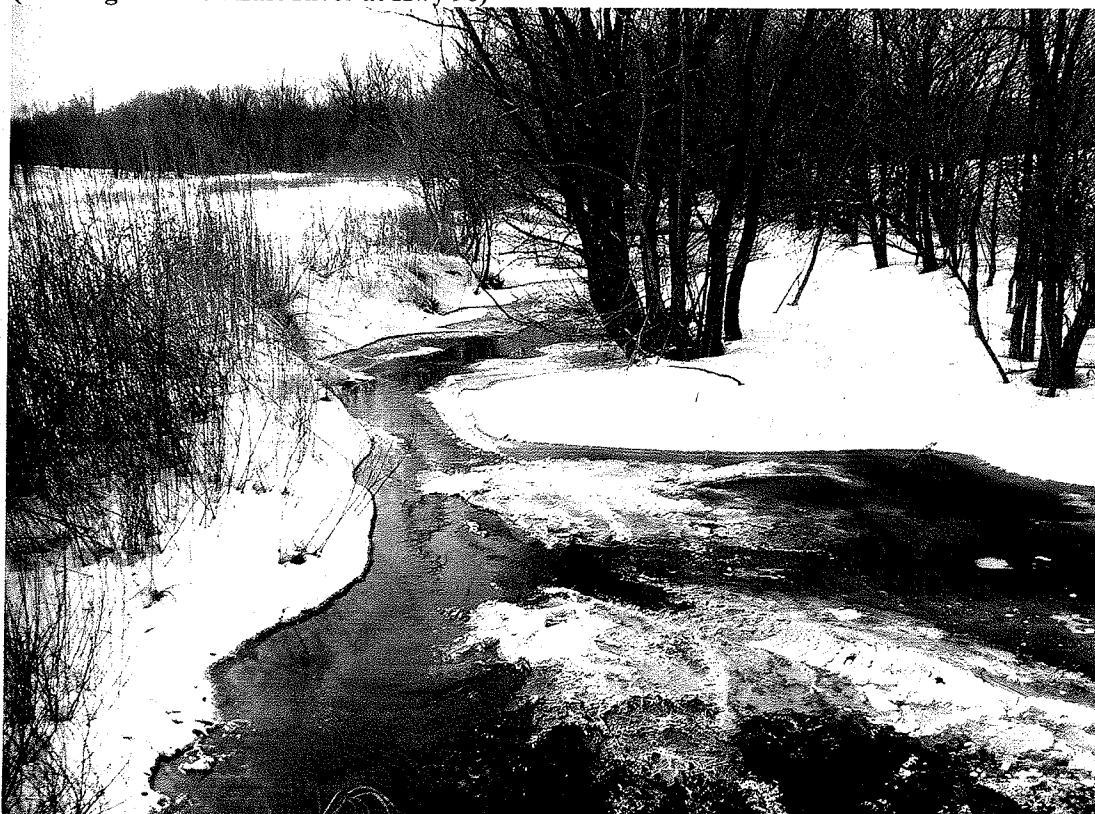
(Looking South on East River at Hwy 96)
